University of Waterloo Formula Electric
Formula Hybrid 2024
Year in Review

May 12, 2024

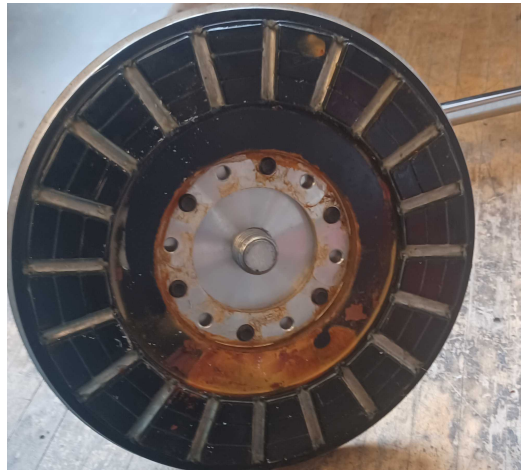
Figure 3: Permanent Magnet side of Emrax 208 Motor that failed (notice significant orange residue (rust), indicative of water ingress)

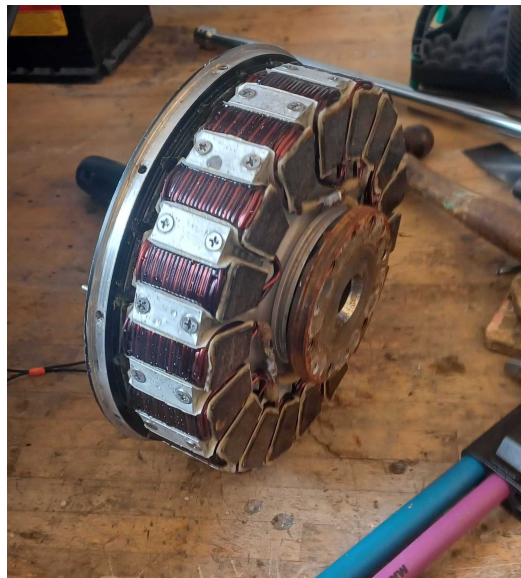
Figure 4: Coil side of Emrax 208, insulation tests showed arcing between case and coils due to insulation degradation around the windings.

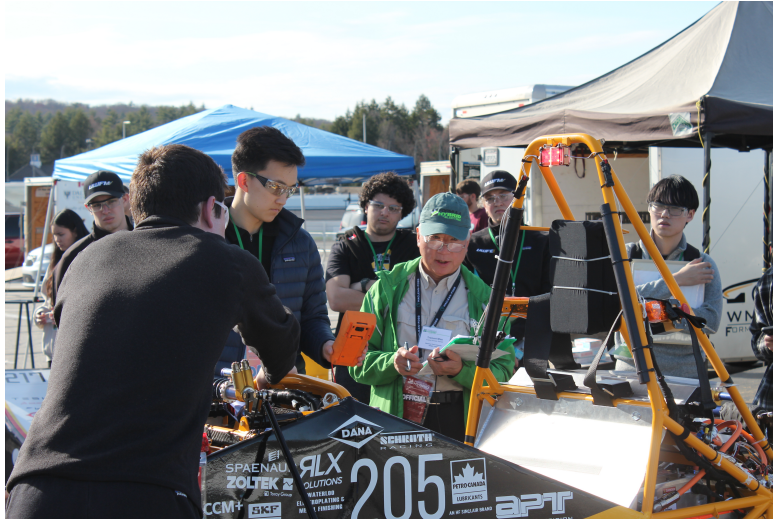
We failed electrical pre-tech for 2 main reasons: failure to ground suspension, and failure to properly discharge. The failure to ground suspension is discussed later, it's a fairly understandable lapse in rules non-compliance, the team now knows about it and is working to correct this. The failure to properly discharge stems from 2 main source: phase cable box installation and PC/DC relay schematic change. As is discussed later, the phase cable box installation generated a tremendous amount of EMI which likely induced

an additional magnetic field which kept the relay open, the reason this hypothesis is stated is this behaviour of failure to discharge in an appropriate time did not occur until the phase box was installed, additionally, it only occurred at “Ready to Drive” not at the HV (Energized) state. The PC/DC relay schematic change is an additional necessary change to ensure discharge under any possible condition.

Figure 11: Electrical Pre-tech demonstration with Tremont Miao (TSAL failing to discharge in time)

Justin and I worked hard to remedy the 2nd issue, while the suspension team worked hard to get relatively good grounding. Eventually we were able to breeze through pre-tech again, then we progressed to electrical tech. Electrical tech went quite smoothly but we failed during the testing phase, when we would bring the car to Ready to Drive it would almost immediately fault. This stems again from the phase box installation which generated a tremendous amount of EMI such that the car could not stay at Ready to Drive stably for more than a few seconds without faulting. We got permission to run the car on the stands, brought it back to the garages, performed some voodoo magic and got it to work. As a side note one of the voodoo magic tricks I performed was I randomly just removed the motor thermistor connection to the inverter and the car developed some sense of nominal stability and could work for more than a few seconds without faulting. I hesitate to state with significant confidence the reason behind this but it's likely EMI by conduction through improper grounding which is connected to the issue of the motor being poorly grounded.

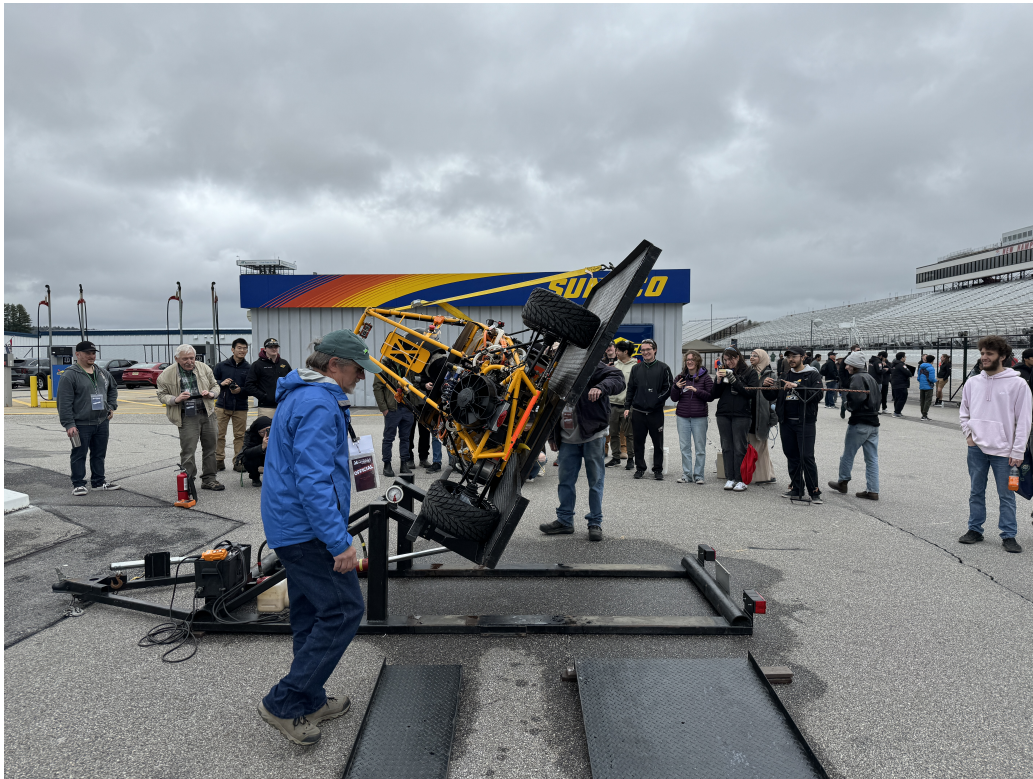
For the tilt test there were some issues though I do not have a ton of visibility on this as I showed up late. To my understanding with the current vehicle setup the car had a marginal amount of tilt at maximum angle of the tester. This was remedied by removing some air from the tires and playing with some suspension configurations to yield a car that did pass tilt to the satisfaction of the judges, supposedly this is legal and after that test you can then fill the tires again and retune the suspension, which is odd to me, but they accepted it.

Figure 13: Demonstration of failed tilt test of vehicle (note visibility under right rear wheel)

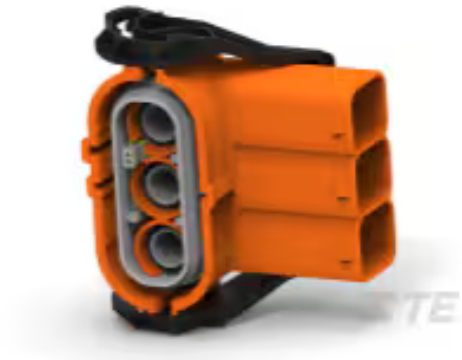
The backstory of the phase cable box goes as follows. Mere days before competition (perhaps 2 if my memory serves correct) the powertrain team “discovered” that there needs to be a waterproof enclosure around the phase lugs. to the motor This is in fact something that has be known but it appears this was completely forgotten. The day before competition, the phase cable box was manufactured last minute and was installed at competition. The design for the phase cable box was setup to use the HVP 3 position connector. The powertrain team was not prepared to manufacture this assembly, did not have the appropriate crimper, appropriate crimps, cabling or assembly ready. This meant after many hours of installation at competition, they had to machine a special plate and use the cable glands that were used in the 2023 car. This modification of the design also made the box completely unserviceable such that any changes would take in excess of 5 hours. All of these modifications and changes took an incredible amount of hours such that the team was very late to competition and had no time to perform proper pre-comp testing in New Hampshire.

Figure 19: HVP800 3 position connector, initially expected to be mounted on the HV box, aborted at competition due to lack of preparation.

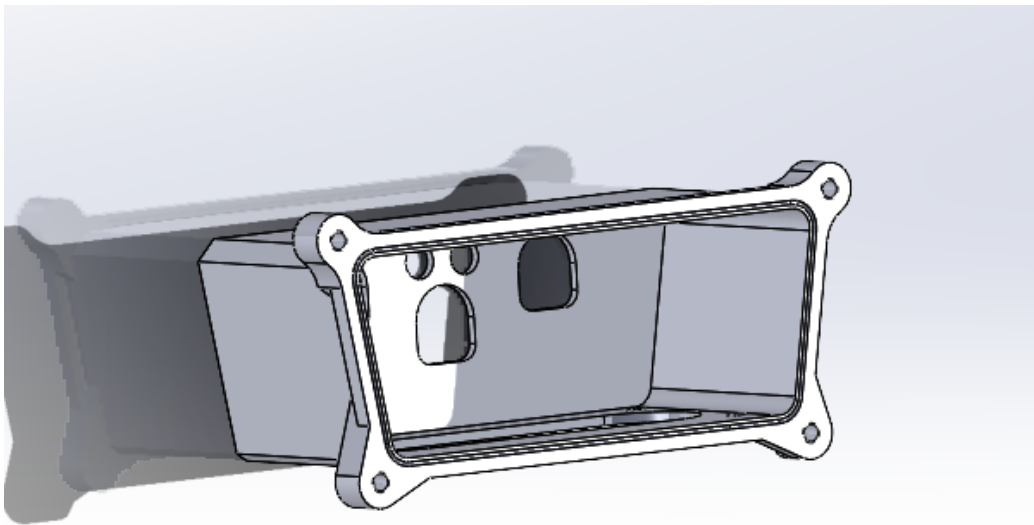
Figure 20: HV Box which hold the 3 phase cables

Not only though did this change remove an incredible amount of testing and validation time away, it also introduced a new issue. Now with the

phase box installed there is a tremendous amount of EMI being generated and coupled into the inverter. The EMI would cause the resolver readings to be off which would cause instability in the inverter's control loop and cause a hardware overcurrent fault inside the inverter. Resolving EMI issue is a non-trivial issue, it's something Justin and I had to deal with earlier but we had sufficient time and were able to implement a fix for the previous issue. Now we are at competition and the car cannot stay at "Ready to Drive" for longer than 5 seconds without faulting because of the addition of this box. The exact reasoning for the introduction of the issue is unclear and will require EMI investigations, it's possible it's due to HV coupling, it's possible and perhaps most likely due to poor grounding. The issue of grounding will be discussed in the "Motor Grounding" section, but the gist is, the powertrain was completely rules non-compliant given the motor and phase box were not at all grounded. Attempts were made at competition to ground them, but due to the poor grounding performed this did not vastly improve the EMI issue.

After insane late nights, we were able to develop a slight fix in where the thermistor wires were disconnected and this yielded marginal vehicle stability, but under almost any load the vehicle would fault. The change implemented was whenever a motor controller fault occurred the firmware would power cycle the inverter. This is a bad change, it posed a threat to vehicle stability, drivability, component health and vehicle health. However, it was a necessary change to drive the car and yielded a car that was able to

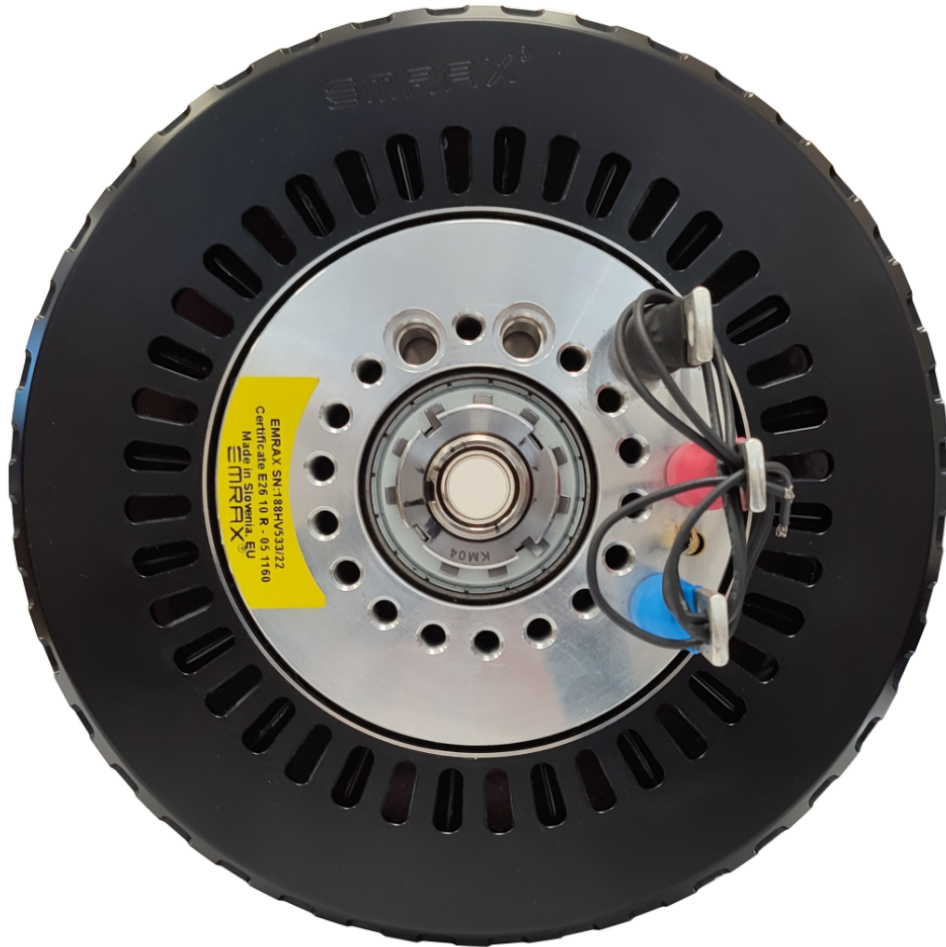
A major issue that happened multiple times on the vehicle as well as occurred on the dyno was phase cables having incorrect ordering. Given the very poor serviceability of the phase cable box this became a very pressing issue as incorrect phase cable ordering would have a turn around time of 4 hours, so all in approximately 8 hours of time would be wasted in installing phase cables because they were installed incorrectly. This section is left in as a reminder to the powertrain team and to future generations, the phase cable order matters. Do not trust your gut, there is a 1 in 8 chance you get it randomly. On Cascadia's website there is a document for setting up the Emrax motor where it explicitly details to you which order to put the phase cables from the inverter to the motor, ensure this is done properly. This also comes back to lack of validation the people installing the phase cables did not validate or do a 2nd check. A simple look at documentation would easily reveal the mistake, yet it was made multiple times when installing the phase cables. Measure twice, cut once.

Figure 24: Emrax motor (phase connections are the black, red and blue connections)

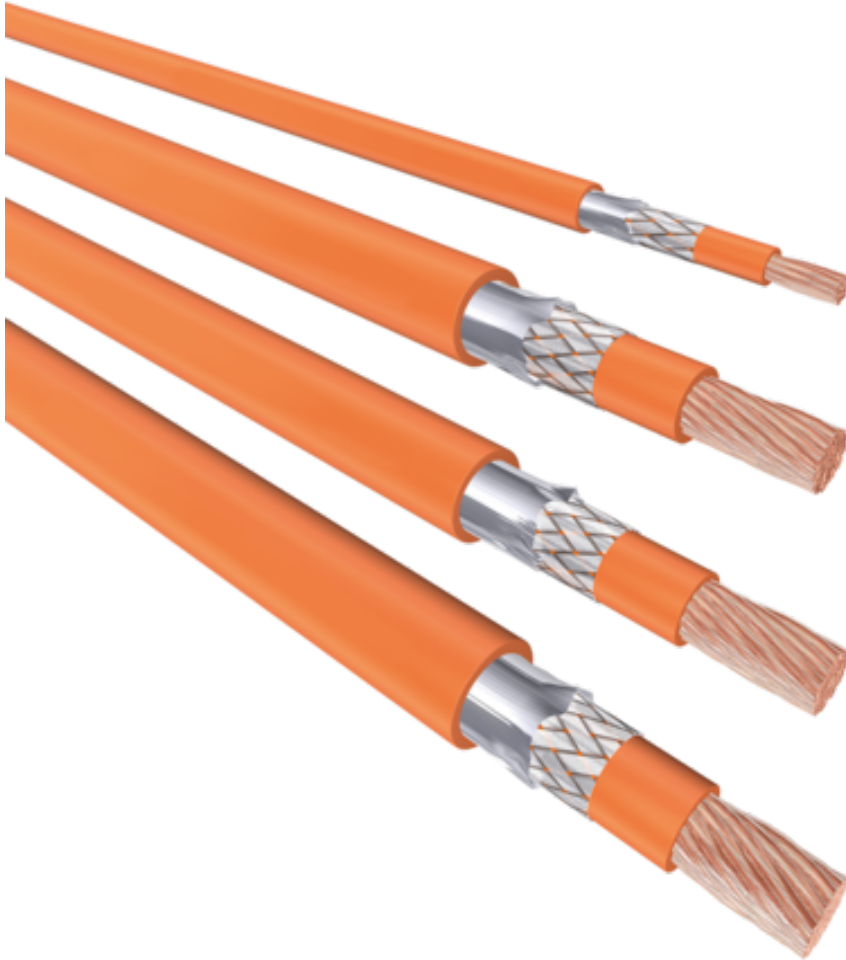
A major safety, timeline and vehicle threat was caught on the dyno. During dyno tuning, multiple days were consumed attempting to tune the inverter to the 228 motor we had procured. After a few days of failed tuning it was

eventually identified that a critical mistake was made in crimping the high voltage cabling. When the dyno team hooked up the inverter to the motor, they cut back both insulation layers and then wrapped the GLV shielding around the copper conductor, this resulted in the high voltage connections being shorted directly to GLV ground, which in the case of the inverter is the case itself. The motor controller tuning was failing because there was high voltage being coupled directly to the chassis of the inverter, this is a major, major, major safety issue.

Figure 25: Shielded High Voltage Cables. The bright orange is the insulation. The copper color is the actual conductor connecting the high voltage systems. The silver color is the aluminum shielding which is to be connected to GLV ground.

The method for cutting and crimping these high voltage connections is documented online rigorously. This failure also demonstrates a fatal misun-

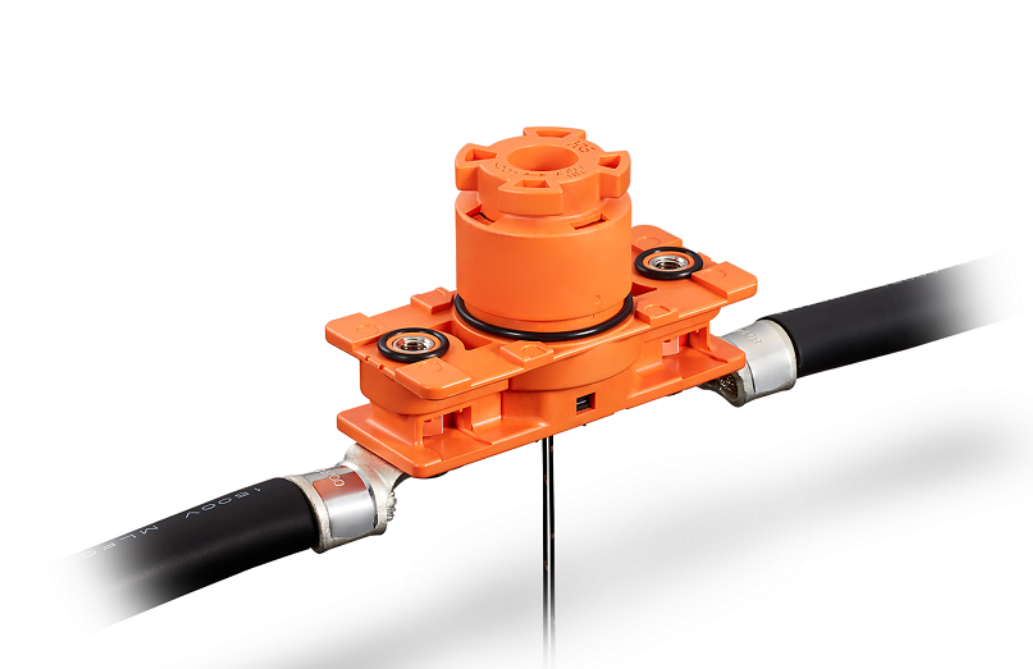
Figure 28: Hirose MSD, the HVD used on the car. The HVD IL is the black wire exposed underneath the orange enclosure.

Part of the issue is connected to the previous discussed issue of crimps, but after that issue was remedied it's simply an issue of failure of validation. The root cause of this is failure of crimps, solder joints and general electrical connections. However, the real issue is failure of validation. Multiple times the rear lid was given to members and it was returned as "connected properly now". However, this is clearly false and easily disprovable using a multimeter, the IL was not actually closed and the HVD was skipped in the IL loop which posed a design flaw, minor safety issue and potential inspection failure given our ESF did not match our vehicle design.

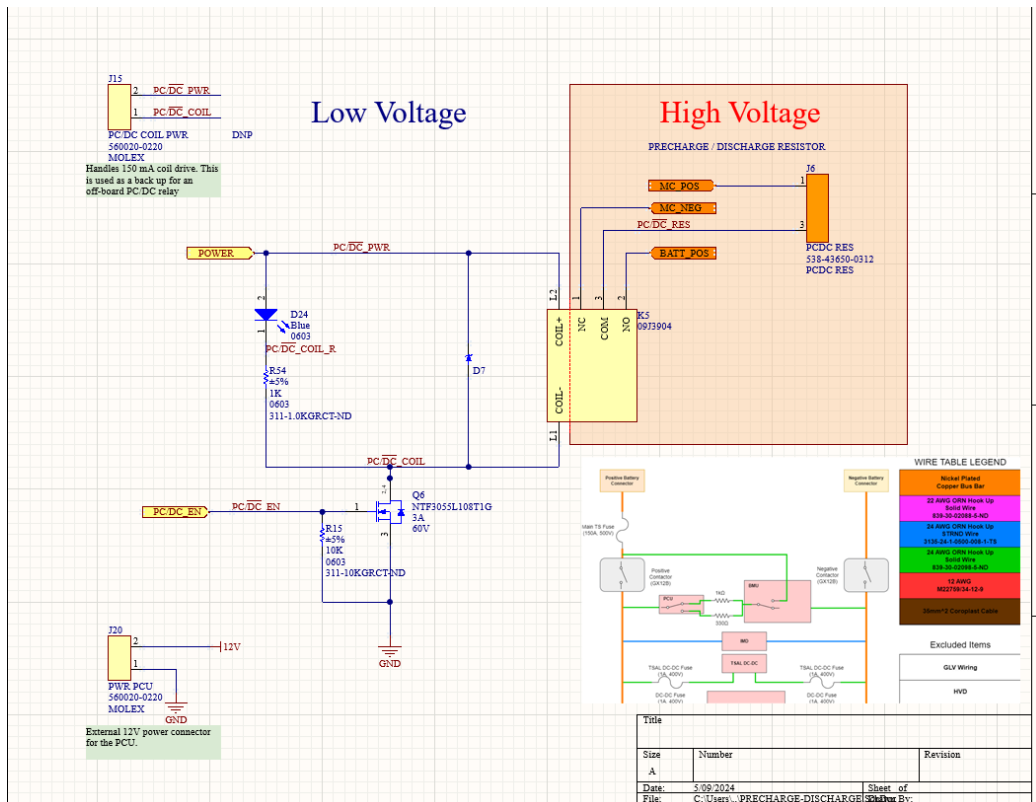
During electrical inspection the team failed during one of the demonstrations. The demonstration failed was while at "Ready to Drive" hit the side BRBs, this should cause the TS system to discharge within 5 seconds. Hitting the side BRBs appropriately deactivated the GLV system but failed to discharge the TS system in an appropriate time, it took approximately 1 minute. This 1 minute time frame matches with a discharge against the parasitic discharge resistor in the motor controller. This was indicative that the positive and negative AIRs had opened, but the PC/DC relay had not returned to the discharge state. This is a very peculiar issue as the relay is a normally open relay in the discharge state, given there is evidently no GLV power being supplied to the relay how can it remain open? The schematic shown below is the PC/DC schematic for the 2024 BMU.

Figure 29: PC/DC Relay on 2024 BMU

The issue was that the PC/DC schematic was virtually copied from the previous 2021 BMU project and the relay was swapped out. There was a failure in analysis in that the relay was swapped for a high voltage relay to support the 300->600V architecture change but analysis was not performed on the flyback diode. The relay has a very low dropout voltage of ~0.5V. However, the forward voltage of the flyback diode is around 540mV for any real current. What was likely happening is when the power to the relay is disconnected the diode actually keeps the coil conducting by providing a path for current to flow while not bringing the voltage below the drop out voltage.

This oversight was caused by lack of analysis spent on the BMU. This is a flaw in the logic of designing the BMU where it was assumed that the old schematics were perfect and good, so we should just make minor adjustments. The issue is, an older designer designed these PCBs with certain design decisions, those are not documented in the design as that would be too verbose and time consuming, and when we change the system design the previous assumptions become invalid. The old PC/DC relay had a very large dropout voltage in the single digit volts, thus this was not at all a concern. Another factor which should be considered is that this iteration of the BMU despite the very minor changes required took ~12 months to complete, and respins are still being sent out as of the writing of this document. Given the efficiency of prior generations of the electrical team it's likely we overestimated the capability and efficiency of the current electrical team to produce PCBs, going forward ambitions should be scaled back.

discharge the coil and provide a path for conduction besides the diode. This seemed to fix the issue. Though it should be noted this issue had not arisen previously as it was exacerbated by the EMI changes from the powertrain changes see other sections for more information.

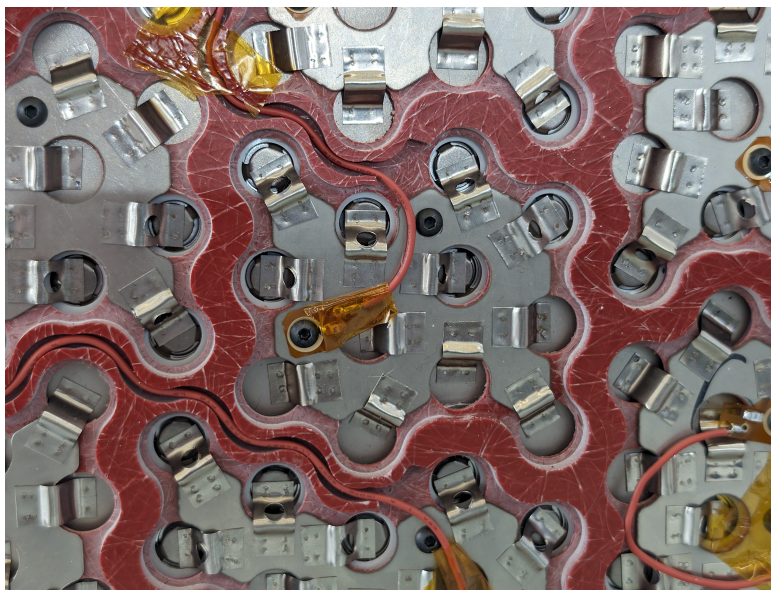
PCBs at the start but discarded them before installation because I ran this check. This took a tremendous amount of time to fix as I had to tear apart all but 1 segment, identify which sense wires were broken, re-solder the PCBs, recut and crimp the wires.

Figure 31: Ring Terminal PCB on segment

The segment team needs to run full end to end testing of all their components, it's a serious issue at this point, identifying the issue when you're assembling the segment is a lot easier fix then fixing all the broken ones at the end. The segment team should also be comfortable with running proper integration testing, that is attaching the AMS boards and reading values from them, this is something the team will need to do to run tests when I'm gone.

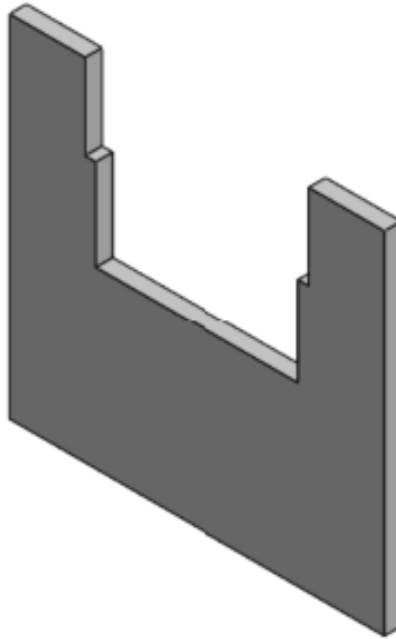
There were quite a few assembly issues with the accumulator segments, enough that I can't really go over all of them. I shall go over the main one which is in terms of dimensions. When fully assembled the segments are too wide and too long. Too long to the point that the segments did not fit inside the accumulator box when they were to be dropped in. One of the issues I identified was the terminal isolation plate was designed to be an exact press fit into the segment. When it was 3D printed due to slight tolerances it became practically an interference fit.

Figure 32: Terminal Isolation Plate

Rather than reprinting the piece, in the segment it was just placed into the segment such that it protruded forward and didn't properly fit. This caused the axial segment walls to bow out at the top and meant the segment would not fit inside the accumulator box. So what I had to do was tear apart every segment (this requires removing AMS boards and AMS shield and AMS plates and all the G-10 walls. Once the segment was torn apart I had to remove the segment terminal connectors, remove the terminal isolation plate and sand down the plates until they fit back inside the segment. This was an incredibly time consuming process which took well over 40 hours, of working about 6 or 7 all nighters. There were a few other minor methods I used to get the segments to eventually fit inside the box but they were all very time consuming and easily put back first shakedown about a week.

These small things are the types of things which should not happen on a professional team. If you are 3D printing a component, you must factor into it the tolerances, this piece definitely did not need to be press fit in. When installing the component, understand what it does and what effect it has, the fact it was installed such that the connectors would bow out of the segment and bow the G-10 walls is not really acceptable. The fact that the segments were never actually placed into the box with nomex before I did it, is another example of failure of validation.

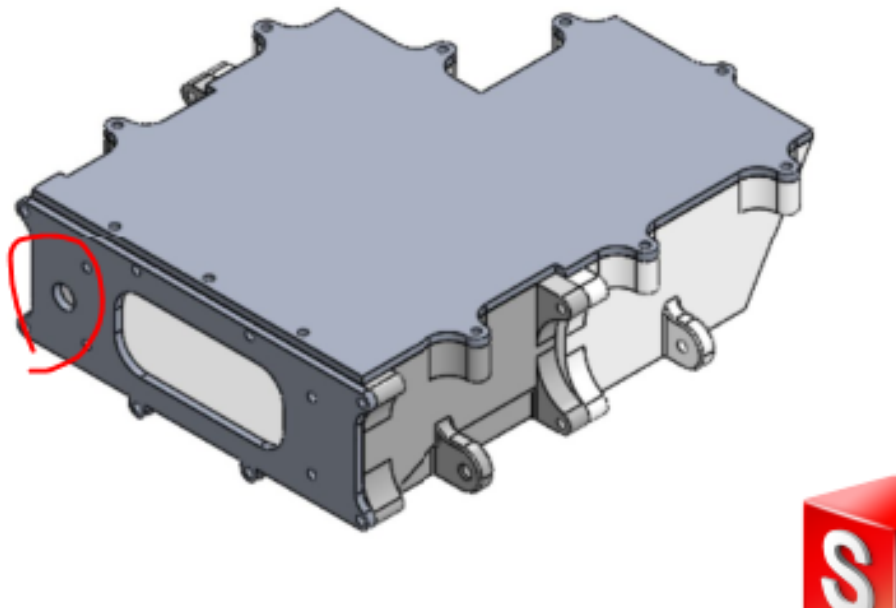
The PDU for the past at least 4/5 years has always had the Hirose programming port mounted in the same spot. This is the worst spot to have the programming port as it requires the full GLV harness to be disconnected to access it. It's practically unusable.

Figure 33: PDU enclosure with Hirose port highlighted

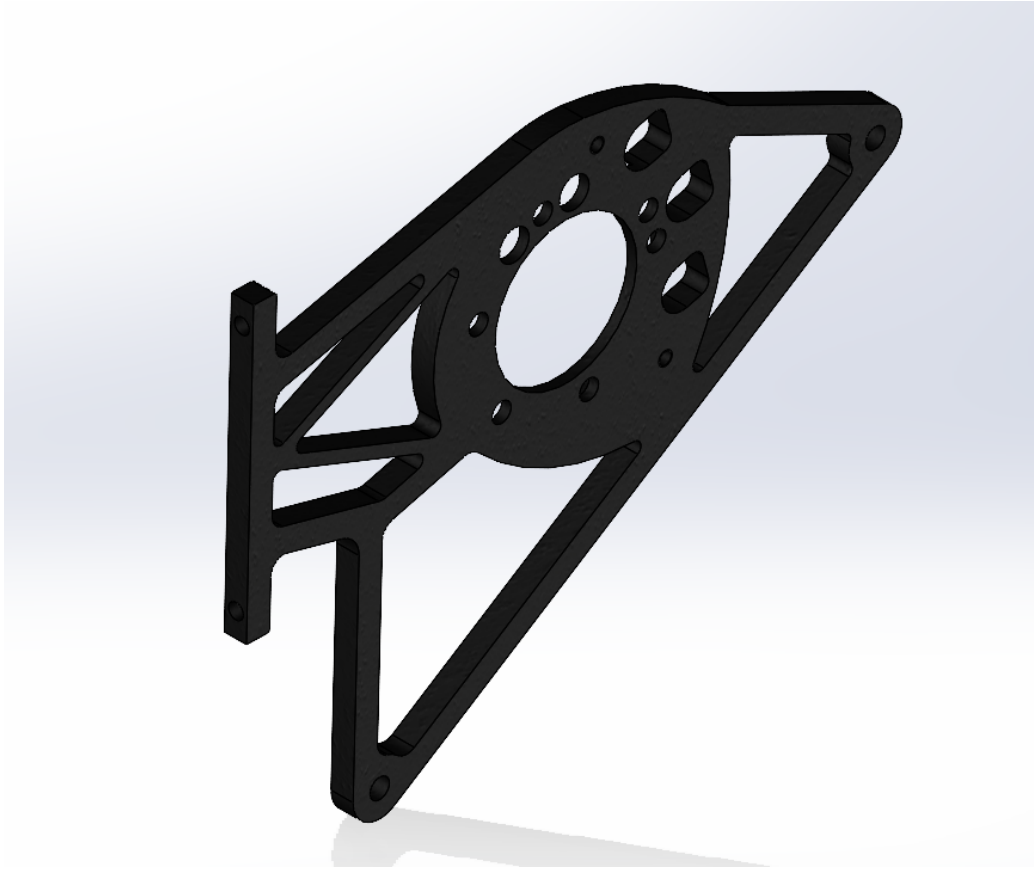
The motor and all it's attached components: phase box, resolver, mount mount were all not grounded. This breaks competition rules which requires all metallic accessible components on the car to be grounded. The inspector especially stressed the importance of grounding things close to the TSV system which the motor mount very much is.

Figure 34: Motor mount

The root cause of the motor being ungrounded, was it was anodized which adds a dielectric layer around the metal preventing any contact to the motor. Not only is this rules non-compliant, it's unsafe and is possibly the cause of the significant EMI issues identified on the vehicle. This is simply an oversight in design. All elements on the car must consider grounding when it comes down to it, especially the powertrain team given it involves TSV components and can generate tremendous EMI. Going forward the powertrain team needs to develop it's electrical understanding, rules compliance and ensure grounding is factored into all of it's designs. Rules checking and validation is something that should be performed at every step of the design

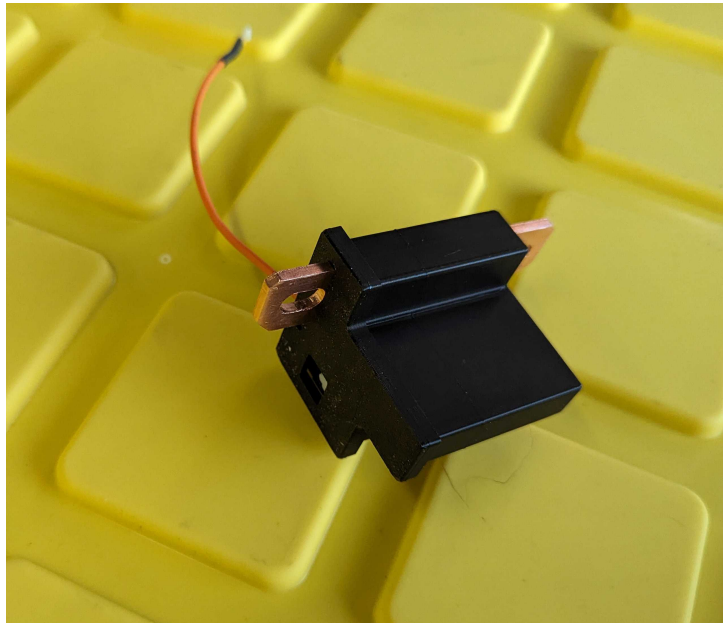
At competition when attempting to install the Formula Hybrid Energy meter, it was quite clear that it would not fit in our box. Multiple hours (~8) were spent integrating this into the E-Box at competition and it ultimately never worked. This blocked vehicle progress and testing. This is primarily the fault of the organizers for not providing more detailed information prior to competition, and for failing to match the spec of the FSAE michigan inspectors. Going forward for Formula Hybrid the team should be prepared for this change, we should have appropriately slotted bus bars, and ample space in the E-Box to fit this in. Additionally going forward, before FSAE Michigan the team should reach out to a team to test fit the FSAE Michigan energy meter in the car prior to arriving at competition.

Figure 35: Formula Hybrid Energy Meter

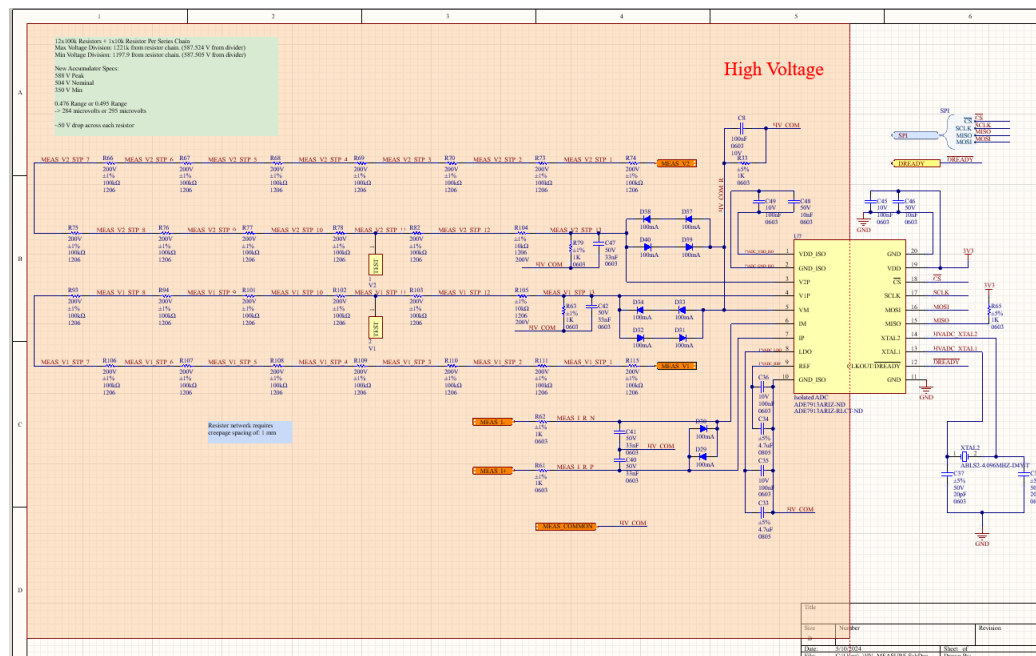
When attempting to precharge the vehicle, we failed multiple times due to incorrect current measurements read from the ADE7913. Eventually it was deduced where this originated from. Yet again, the schematic from the 2021 BMU was virtually copied over without much further analysis. The ADE7913 can only handle a maximum voltage difference between GND_ISO and VM/IM of 25mV. The issue is the accumulator's shunt is connected on the negative TSV side of the vehicle while HV_COM is connected to the positive TSV side of the vehicle as shown below.

Figure 37: HV Measure Schematic for the 2024 BMU

This is another example of the electrical team porting over a change without re-performing the analysis. The shunt change of location is documented extensively in the ESF-2. Going forward the team needs to perform more analysis on the things they do, and need to seriously descope work. The BMU took ~12 months and still is not complete, while it has some fairly significant issues which degrade functionality, not having a shunt seriously degrades the functionality of the BMU.
