University of Waterloo Formula Electric
Formula Hybrid 2024
Year in Review

May 12, 2024

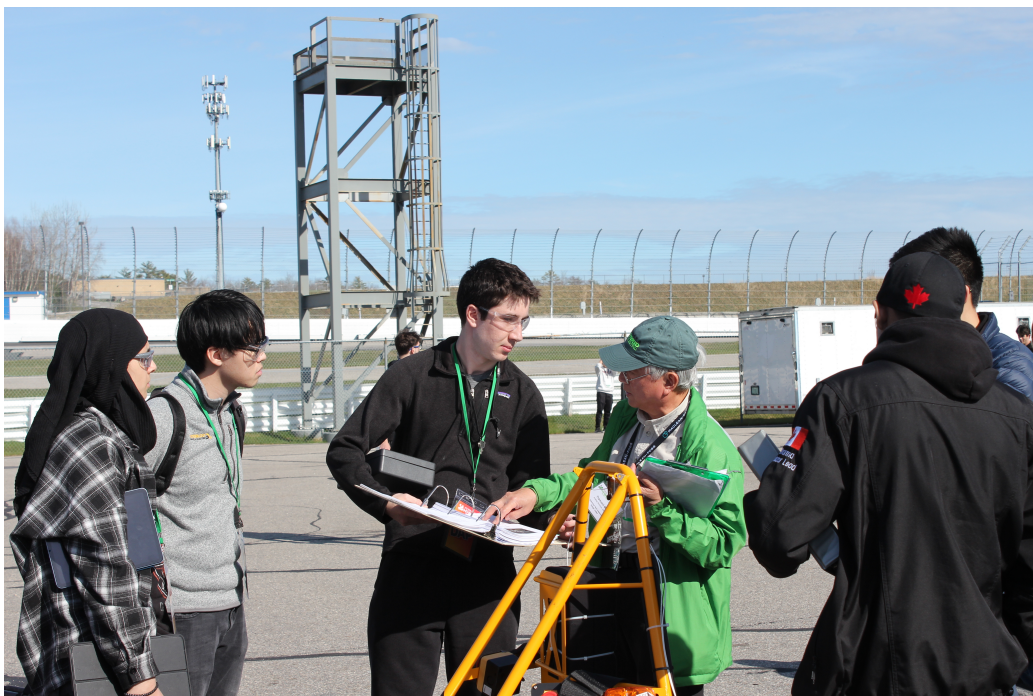
We failed electrical pre-tech for 2 main reasons: failure to ground suspension, and failure to properly discharge. The failure to ground suspension is discussed later, it's a fairly understandable lapse in rules non-compliance, the team now knows about it and is working to correct this. The failure to properly discharge stems from 2 main source: phase cable box installation and PC/DC relay schematic change. As is discussed later, the phase cable box installation generated a tremendous amount of EMI which likely induced

an additional magnetic field which kept the relay open, the reason this hypothesis is stated is this behaviour of failure to discharge in an appropriate time did not occur until the phase box was installed, additionally, it only occurred at “Ready to Drive” not at the HV (Energized) state. The PC/DC relay schematic change is an additional necessary change to ensure discharge under any possible condition.

Figure 10: Electrical Pre-tech documentation discussion with Tremont Miao

Justin and I worked hard to remedy the 2nd issue, while the suspension team worked hard to get relatively good grounding. Eventually we were able to breeze through pre-tech again, then we progressed to electrical tech. Electrical tech went quite smoothly but we failed during the testing phase, when we would bring the car to Ready to Drive it would almost immediately fault. This stems again from the phase box installation which generated a tremendous amount of EMI such that the car could not stay at Ready to Drive stably for more than a few seconds without faulting. We got permission to run the car on the stands, brought it back to the garages, performed some voodoo magic and got it to work. As a side note one of the voodoo magic tricks I performed was I randomly just removed the motor thermistor connection to the inverter and the car developed some sense of nominal stability and could work for more than a few seconds without faulting. I hesitate to state with significant confidence the reason behind this but it's likely EMI by conduction through improper grounding which is connected to the issue of the motor being poorly grounded.

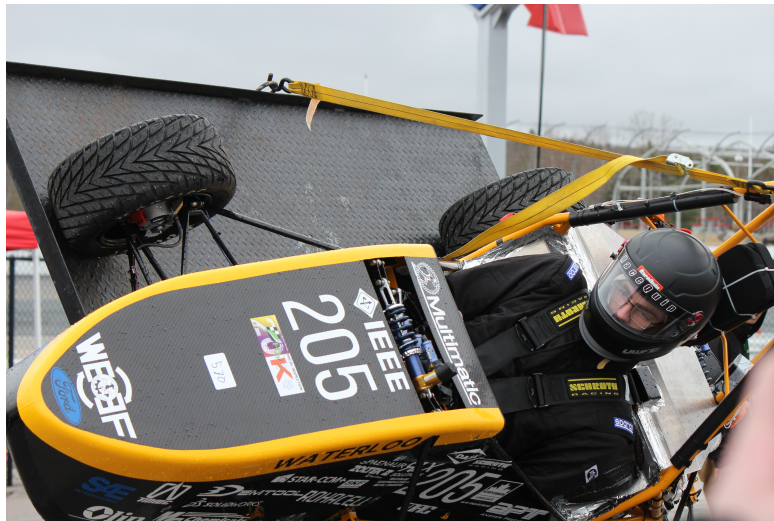
For the tilt test there were some issues though I do not have a ton of visibility on this as I showed up late. To my understanding with the current vehicle setup the car had a marginal amount of tilt at maximum angle of the tester. This was remedied by removing some air from the tires and playing with some suspension configurations to yield a car that did pass tilt to the satisfaction of the judges, supposedly this is legal and after that test you can then fill the tires again and retune the suspension, which is odd to me, but they accepted it.

Figure 12: Tilt test of vehicle

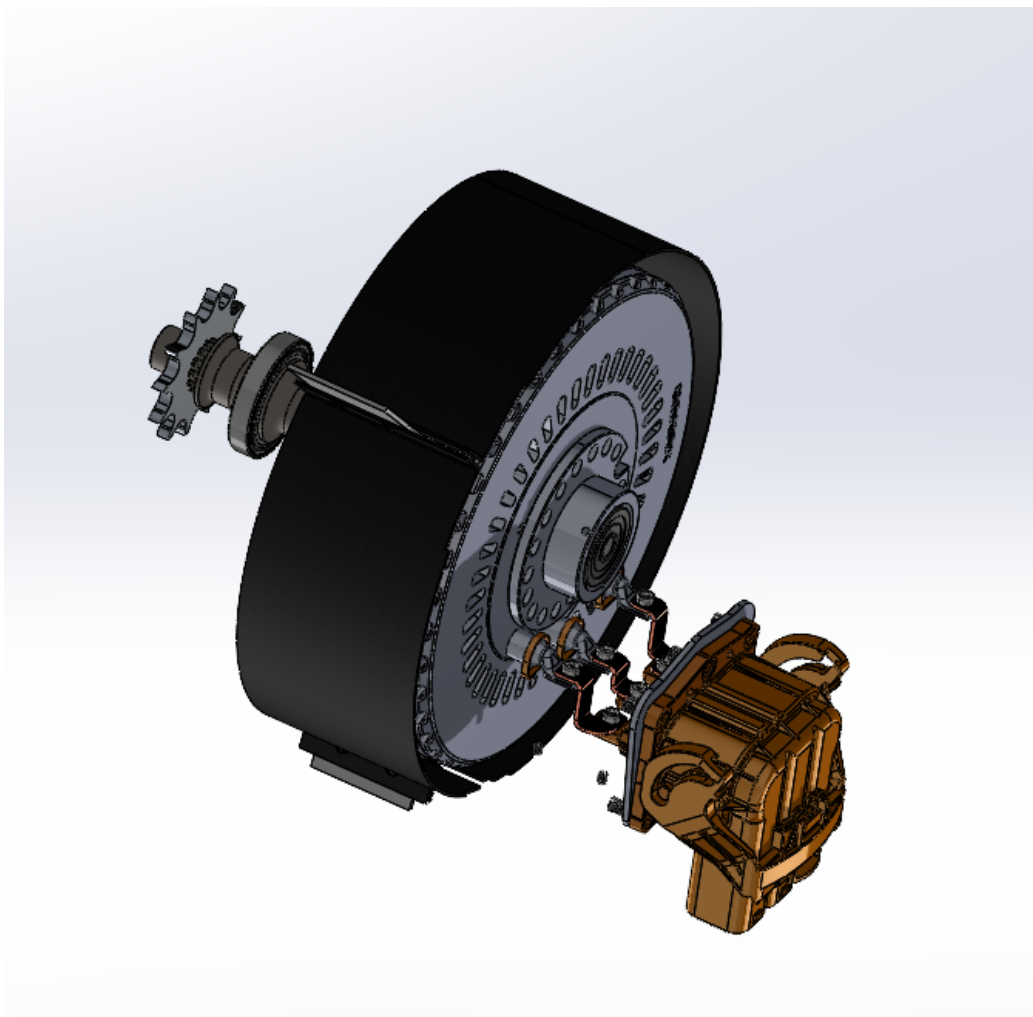
phase box installed there is a tremendous amount of EMI being generated and coupled into the inverter. The EMI would cause the resolver readings to be off which would cause instability in the inverter's control loop and cause a hardware overcurrent fault inside the inverter. Resolving EMI issue is a non-trivial issue, it's something Justin and I had to deal with earlier but we had sufficient time and were able to implement a fix for the previous issue. Now we are at competition and the car cannot stay at "Ready to Drive" for longer than 5 seconds without faulting because of the addition of this box. The exact reasoning for the introduction of the issue is unclear and will require EMI investigations, it's possible it's due to HV coupling, it's possible and perhaps most likely due to poor grounding. The issue of grounding will be discussed in the "Motor Grounding" section, but the gist is, the powertrain was completely rules non-compliant given the motor and phase box were not at all grounded. Attempts were made at competition to ground them, but due to the poor grounding performed this did not vastly improve the EMI issue.

Figure 21: Motor Assembly with missing HV Box

After insane late nights, we were able to develop a slight fix in where the thermistor wires were disconnected and this yielded marginal vehicle stability, but under almost any load the vehicle would fault. The change implemented was whenever a motor controller fault occurred the firmware would power cycle the inverter. This is a bad change, it posed a threat to vehicle stability, drivability, component health and vehicle health. However, it was a necessary change to drive the car and yielded a car that was able to

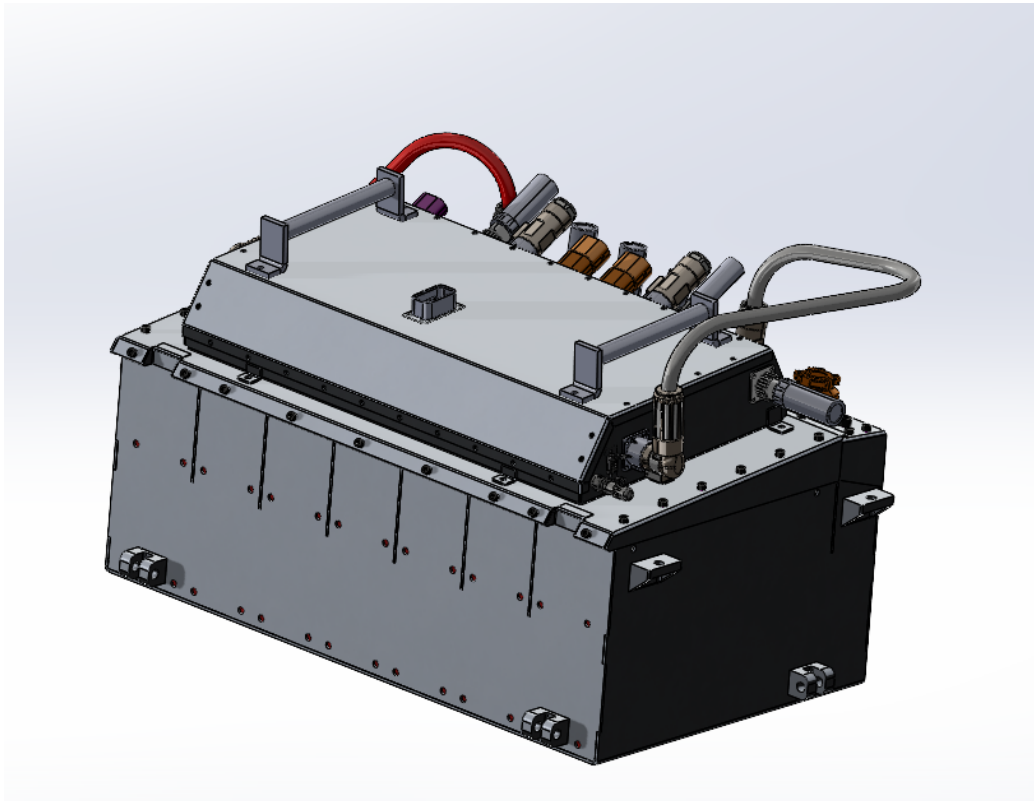
was an unwelded box with no one assigned to the task and no work being performed on it. This was deeply concerning given the tight schedules of the welders at E3. Within the first few weeks of January I had to accustom myself with what was left to complete on the accumulator box and worked on completing and delegating tasks to get that complete.

Figure 22: Accumulator Box

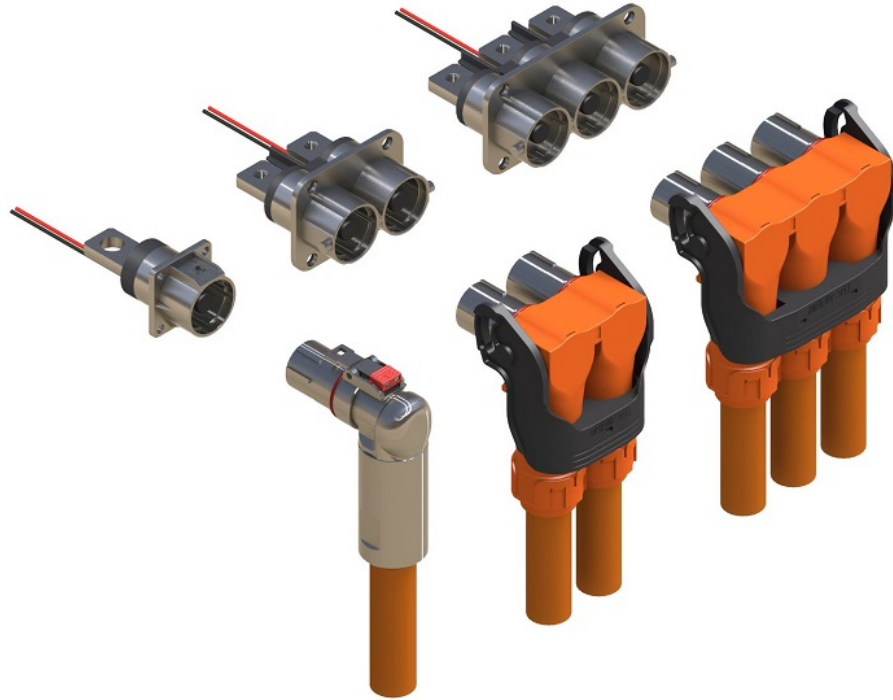
A very large setback for the accumulator was in relation to the connectors. Additionally in January it was discovered that not a single high voltage connector was ordered. This poses tremendous risk as these connectors have very long lead times. The desired connector the powerlok 120 with $16mm^2$ cabling was completely unavailable from any distributor and discussing with amphenol, they had no stock and had lead times on the order of 10+ weeks, well outside an acceptable timeline. Had this not been noticed in January it's possible that the team would not have been able to compete at all given how scarce HV connectors are in the individual distributors (mouser, digikey, etc.). Luckily I found the Powerlok 300 had some appropriate stock, this required us to increase our gauge to $35mm^2$ adding mass and reducing serviceability of the car, but it was an acceptable solution.

Figure 23: Powerlok Connectors

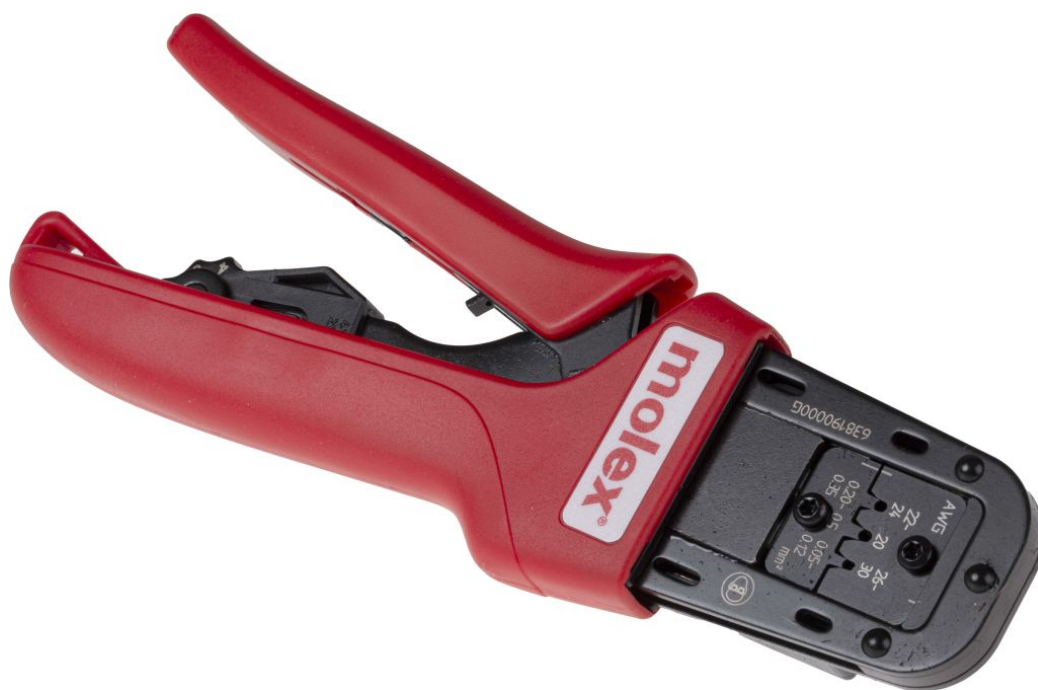
Overall the wire harness was done fairly well. There were still some major issues in relation to crimping and wire management, which caused delays to the vehicle. Despite me (Owen) having stated multiple times that whenever we get a new connector on the vehicle we must ensure we get the appropriate crimping tool and depinning tool, it seems that members decided this was unnecessary. This proved to be incorrect. The HVD IL crimps were so bad they fell right out of the connector, this is because they were not done using the appropriate tool, instead they were brute forced using pliers. The microfit crimps were also quite terrible and would frequently come out of the connectors. We do not have the depinning tool for the motor controller harness and this posed a burden as it limited the changes we could make to the motor controller harness when performing debugging. There are other examples that happened throughout the term but it's not critical to list every incident, they were frequent and caused by the following: lack of appropriate tooling, insufficient number of backup crimps.

Figure 26: Molex Crimp Tool

regard. I stated multiple times that there was no need to sacrifice quality for budgeting, so it's very unclear to me why these items were not procured. The electrical team going forward needs to understand that sacrificing basic quality for cost is incredibly counter productive, bad crimps pose a safety hazard to the driver and delay the car substantially. Whenever a part is acquired we need all the appropriate tooling for said part, if this is distasteful then the team should reconsider acquiring that new part.

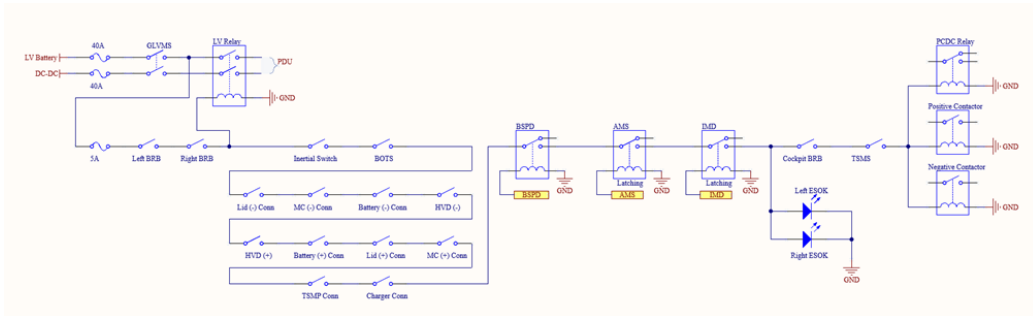
In the team's ESF it was documented that interrupting the HVD would cut the interlock loop as shown in the following diagram.

Figure 27: Interlock loop as documented in ESF, with HVD IL depicted.

Part of the issue is connected to the previous discussed issue of crimps, but after that issue was remedied it's simply an issue of failure of validation. The root cause of this is failure of crimps, solder joints and general electrical connections. However, the real issue is failure of validation. Multiple times the rear lid was given to members and it was returned as "connected properly now". However, this is clearly false and easily disprovable using a multimeter, the IL was not actually closed and the HVD was skipped in the IL loop which posed a design flaw, minor safety issue and potential inspection failure given our ESF did not match our vehicle design.

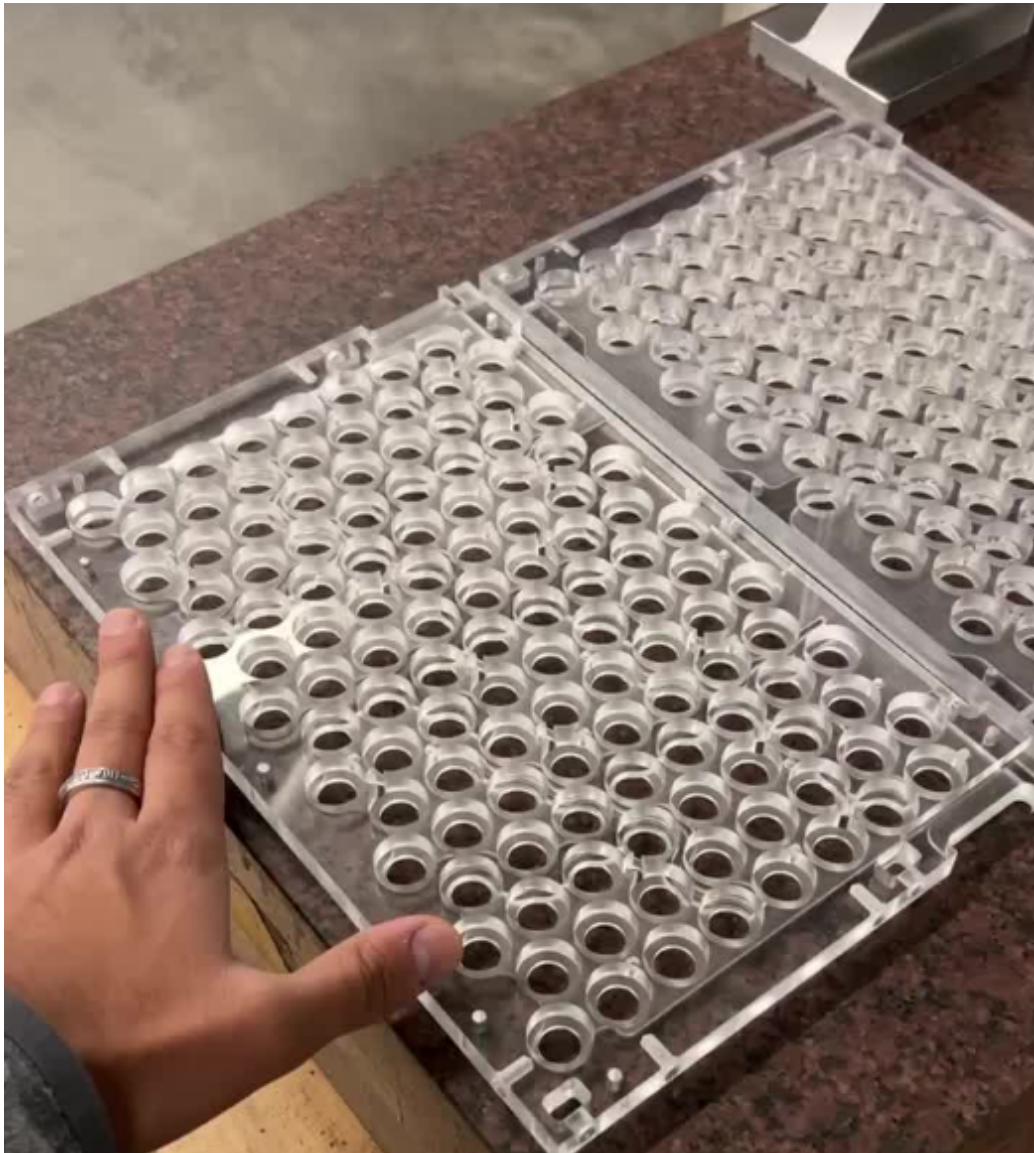
Figure 30: Lexan Segment Walls

The issue is that there was a concern that without annealing the lexan walls would shatter under some of the loads the accumulator experiences, thus significant effort was spent attempting to anneal the material without warping. The accumulator segment team lost about 3/4 months of time,

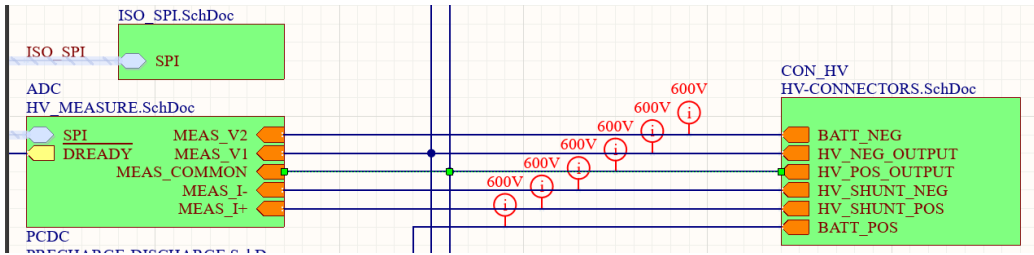
Figure 38: High Level Overview of 2024 BMU with the HV_MEASURE Schematic focused.

When attempting to precharge the vehicle, we failed multiple times due to incorrect current measurements read from the ADE7913. Eventually it was deduced where this originated from. Yet again, the schematic from the 2021 BMU was virtually copied over without much further analysis. The ADE7913 can only handle a maximum voltage difference between GND_ISO and VM/IM of 25mV. The issue is the accumulator's shunt is connected on the negative TSV side of the vehicle while HV_COM is connected to the positive TSV side of the vehicle as shown below.

This topology is a relic of the 2020-2023 vehicle platform where the accumulator had a positive side shunt. However, the topology had to change for the 2024 vehicle as we are using FSAE Michigan’s energy meter which has itself a shunt on the negative side of the accumulator. This means the voltage between IM and GND_ISO during normal operation would be on the order of 500V, well above the 25mV maximum. Prior to competition the shunt connections were removed to prevent any obstacles on this and the hall effect sensor was used. Integrating the hall effect sensor was a non-trivial task which took some time to develop and calibrate. The hall effect sensor is also quite noisy especially at low currents.

This is another example of the electrical team porting over a change without re-performing the analysis. The shunt change of location is documented extensively in the ESF-2. Going forward the team needs to perform more analysis on the things they do, and need to seriously descope work. The BMU took ~12 months and still is not complete, while it has some fairly significant issues which degrade functionality, not having a shunt seriously degrades the functionality of the BMU.
